November 4, 1998

Report on Bioventing System Removal and Well and Monitoring Point

Abandonment at Buildings 457 and 702, Eaker Air Force Base, Arkansas (Contract

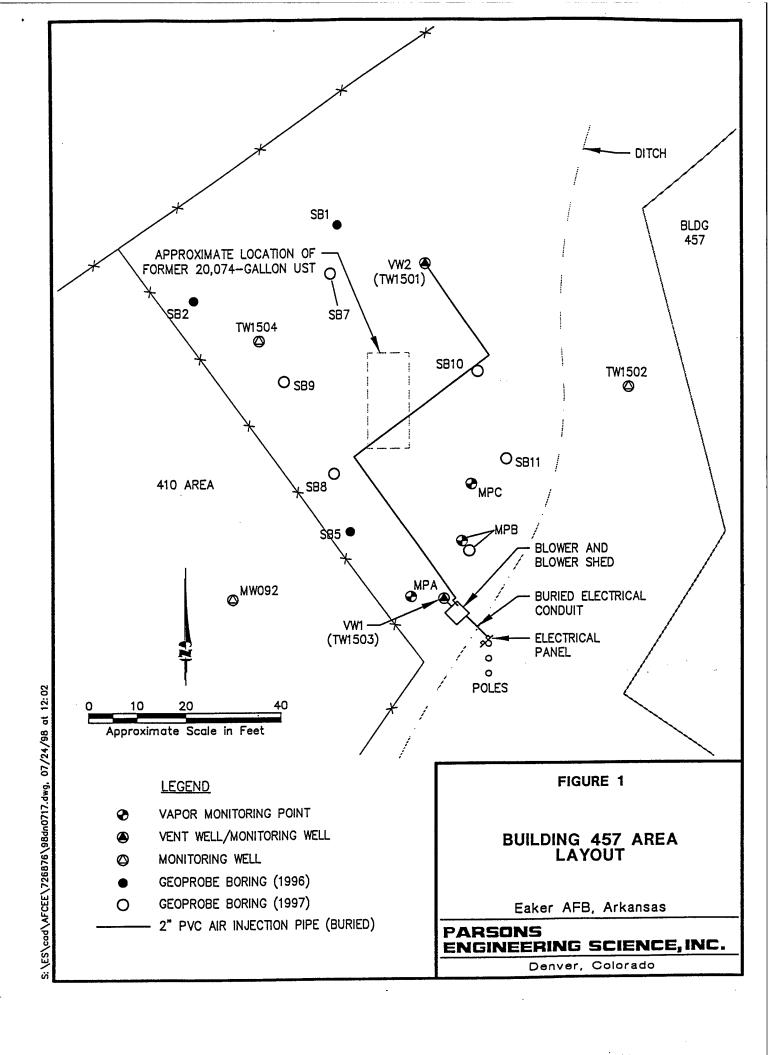
This letter provides a brief description of groundwater monitoring well and soil vapor monitoring point (MP) abandonment performed at Building 457, and bioventing system removal and MP abandonment performed at Building 702, located at Eaker Air Force Base (AFB), Arkansas. Personnel from the Denver, Colorado and Billings, Montana offices of Parsons Engineering Science, Inc. (Parsons ES) and a qualified local electrician performed the abandonment activities in September 1998. Site layouts for Buildings 457 and 702 are provided in the attached Figures 1 and 2, respectively.
